GRAVITY GRADIENT STABILIZATION SYSTEM

APPLICATIONS TECHNOLOGY SATELLITE

FINAL TECHNICAL REPORT
Hardware Development and Test
VOLUME II

FINAL REPORT
FOR THE
APPLICATIONS TECHNOLOGY SATELLITE
GRAVITY GRADIENT
STABILIZATION SYSTEM
VOLUME II
HARDWARE DEVELOPMENT AND TEST

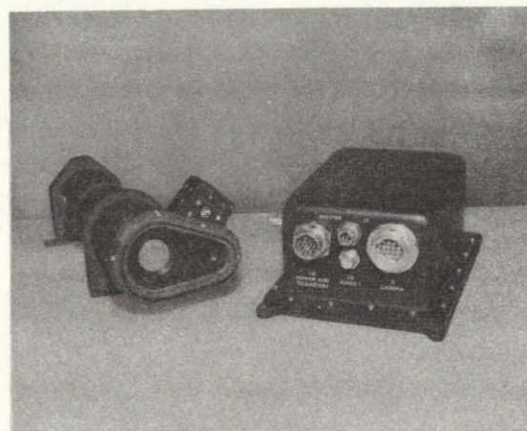
Figure 1-1. ATS Gravity Gradient Hardware

The two primary boom packages (A of Figure 1-1) erect booms tipped with weights in an X-configuration. DC motors in the boom package allow the length of each boom to be varied to effect changes in spacecraft moment of inertia magnitudes and the angle between booms to be varied - over a 20-degree range - to effect a variation in spacecraft moment of inertia ratios (scissoring function). Gravitational and centrifugal forces, acting on the tip weights and gravity gradient rods, provide small restoring forces to orient the spacecraft in the three principal axes.

The Damper Boom (B of Figure 1-1), consists of two self-erecting, 45-foot rods which are attached to a damper shaft. The shaft, in turn, is coupled to the rotor of the Combination Passive Damper. The Damper Boom is shown in its stowed position at the bottom of illustration C, Figure 1-1. The weight of the tip masses at the end of the Damper Boom, the boom length, and the restoring spring constant of the CPD are selected to "detune" the damper boom from the spacecraft oscillatory frequency, thus insuring relative motion of the spacecraft and the Damper Boom.
